CASE STUDY: BURNSIDE BRIDGE RESTORATION

Posted by Bronzella Cleveland | Jan 12, 2018 | Articles, Features, Spotlight | 0

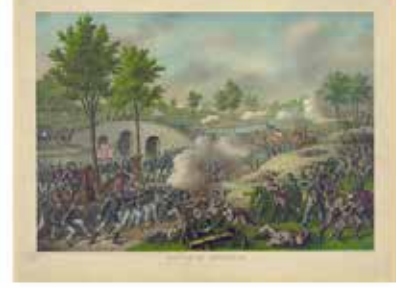
Preservationists and engineers found this would take more than a cosmetic touch up. The walls suffered from substantial deterioration. Water infiltration in the piers had caused structural instability.

The Historic Preservation Training Center's preservationists devised a two-phase restoration plan: in-stream work on the stone piers and arches, followed by selective dismantling and rebuilding of large sections of the bridge walls. The price tag? \$1.7 million, plus months of limited-to-no access for site visitors.

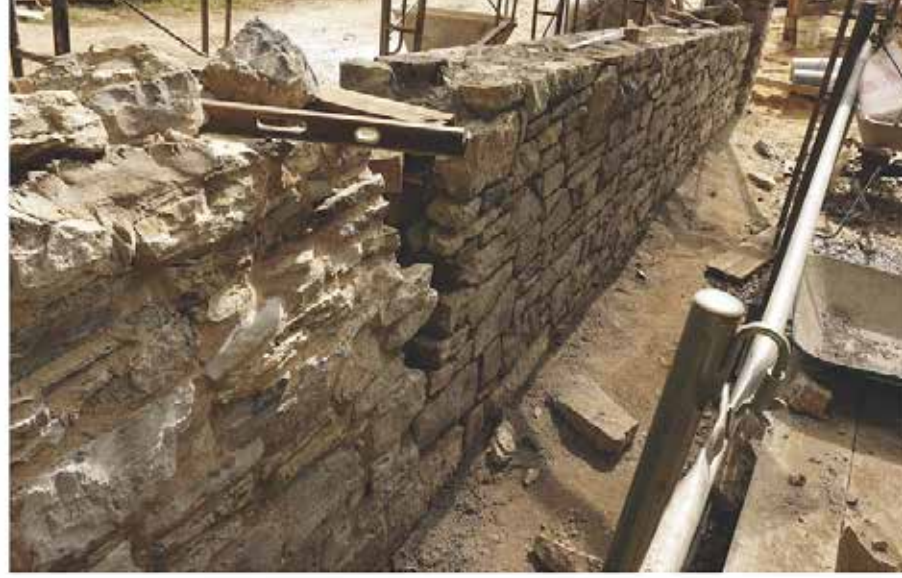
Attacking the first challenge first, Witmer crews created a safe, dry work area by building cofferdams, relocating them time and again as work progressed down the bridge's expanse. They also draped metal skeleton frames with heavy-duty waterproof canvas and secured them with sandbags. Then it came time for the water pumps.

The design called for seepage through sediment, necessitating the addition of seven pumps. Though because they would provide high pressure washing in preparation for repointing and then again to facilitate cleaning, these pumps proved more than useful. After initial adjustments, they remained intact—with one exception.

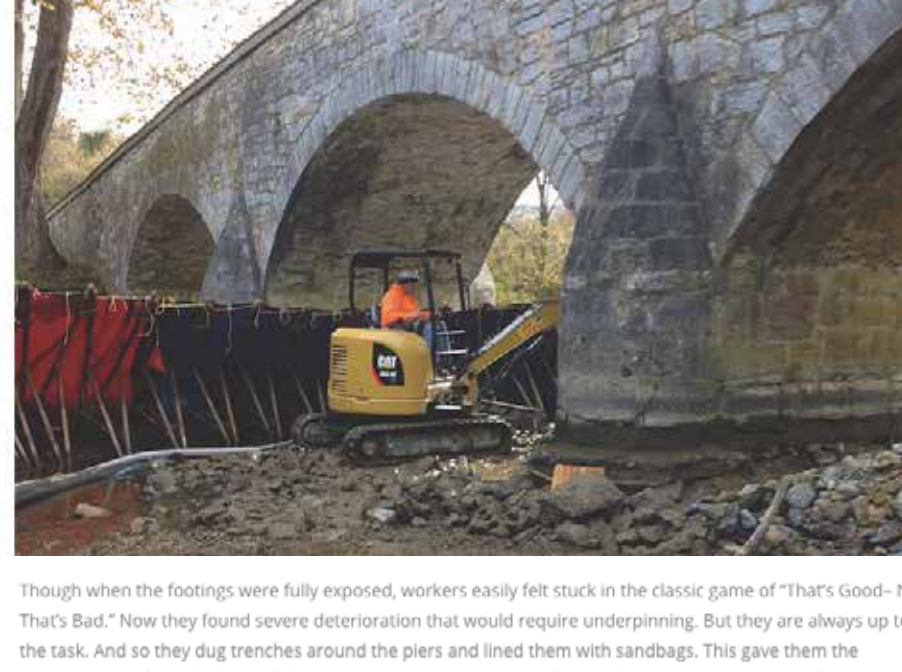
Though the footings were fully exposed, workers easily felt stuck in the classic game of "That's Good—No, That's Bad." Now they found severe deterioration that would require underpinning. But they are always up to the task. And so they dug trenches around the piers and lined them with sandbags. This gave them the opportunity to form the base of the piers with eight cubic yards of poured concrete on each new footing, and fortify them with epoxy-coated rebar.

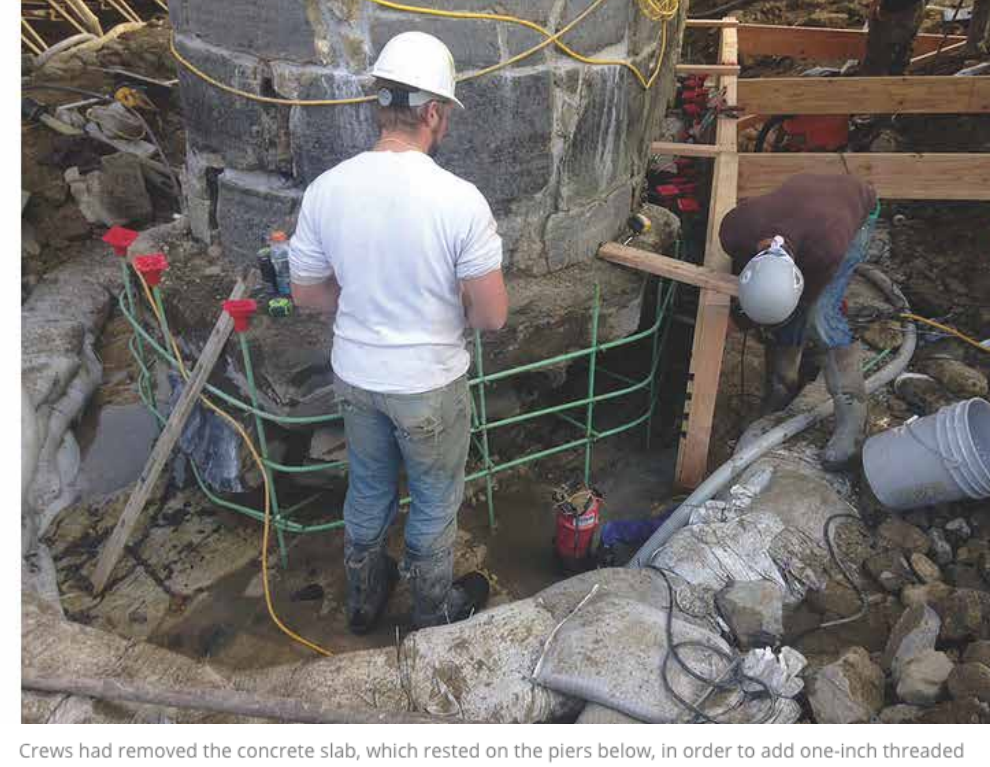
Crews had removed the concrete slab, which rested on the piers below, in order to add one-inch threaded stainless steel tie rods for additional structural support. They poured a new slab to encase the new and existing tie rods. With new footings, with flowable fill stabilizing every crevasse, and with the added tie rods, the piers' long-term structural integrity was assured.

Now it was time to internally stabilize the piers. This require working with a natural cement grout, an inherently expensive and difficult to find material. It was also challenging to effectively inject the stuff into hidden, uncharted empty spaces (such as the pier cracks) as flowable fill. They did so by dividing the piers into two lateral segments: the first from the footing to approximately half-way up the spring line; the second extending at the bottom of the existing concrete slab (as a part of previous repairs, concrete slab had been added to support the roadway). They piped grout into ports until it was forced out of exit ports above. Then they sealed the lower ports and repeated the process in the upper section.

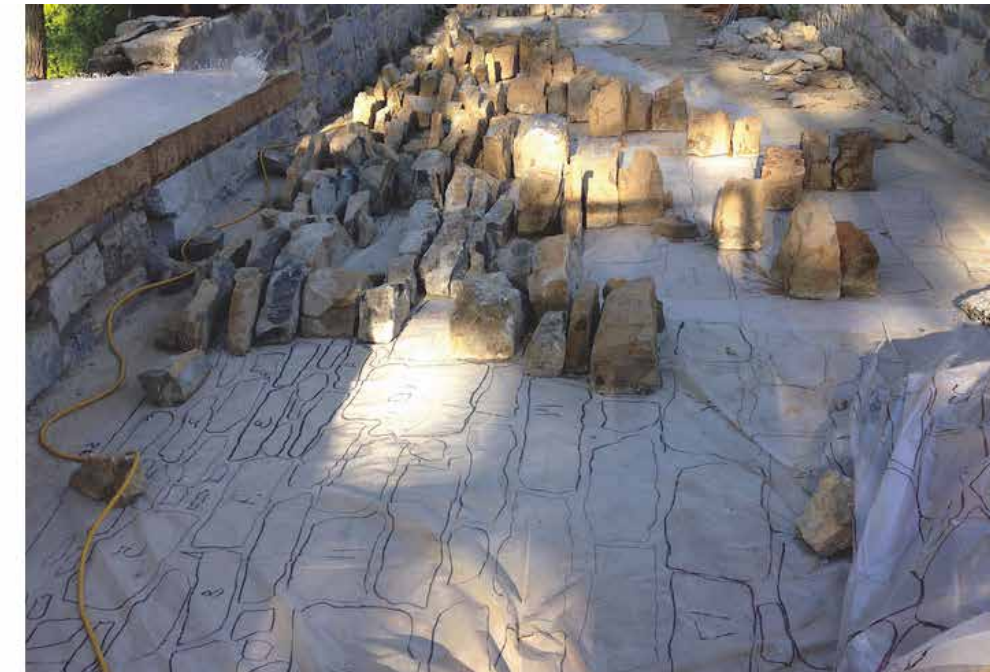
Witmer Restoration's team devised a system that divided the project into vertical numbered segments, allowing them to create an accurate map. Crews hung poly sheets, outlining each stone, numbering character stones on both map and stone faces. A duplicate copy of the map was created and laid on the ground, onto which stones that had been extracted would be temporarily placed.

In the next phase crews focused on dismantling and rebuilding stone facing. This entailed keeping the stoned in as close to original order as possible, not betraying the prolific discern to restore to the original. The goal—and challenge—was to create a finished product that would be barely distinguishable from the original. Work crews had already removed and cleaned the majority of facing stones. They removed the deteriorated material immediately behind, placing nets across the scaffolding to capture virtually all the debris, protecting creek waters below. They used corrugated tie anchors epoxied into interior stones to build upon stability, and then replaced facing stones into their original configuration using carefully detailed charts.

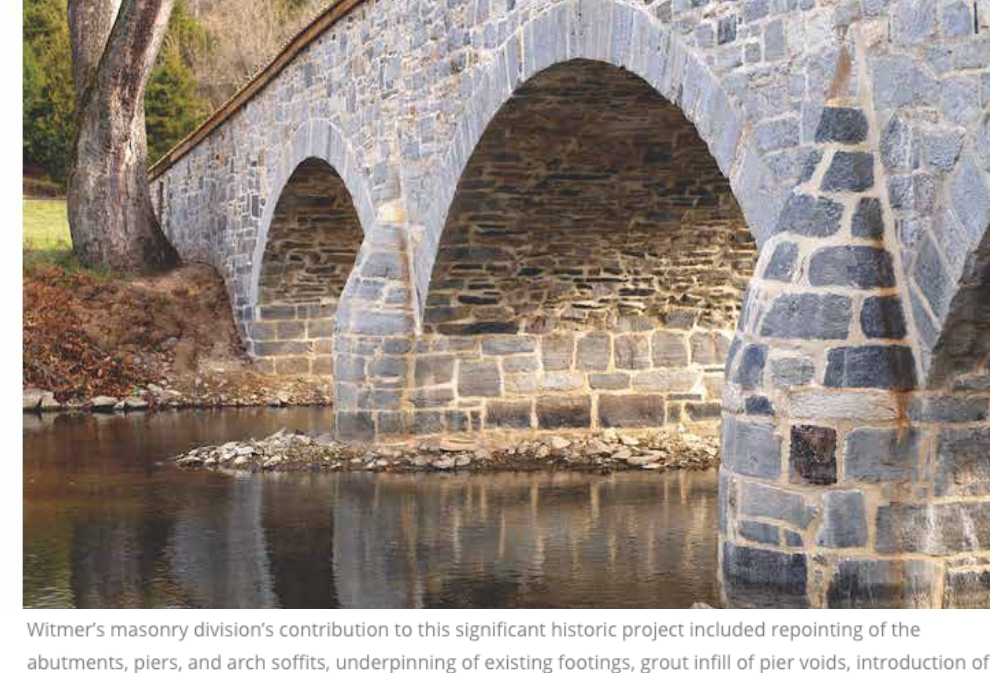
Witmer's masonry division's contribution to this significant historic project included repointing of the abutments, piers, and arch soffits, underpinning of existing footings, grout infill of pier voids, introduction of stainless steel tie rods, and the dismantling and rebuilding of parapets and spandrel stones. Along the way came some challenges and some innovations, matters of opportunity and necessities of invention. But that's all in a day's work.

Finally, coming to a close on the project, crews added a natural lime mortar wash atop the parapets in preparation for a waterproof membrane, stainless steel pan flashing system, and finally an oak shake cap system at the parapets to match the original design.
